Mimosa Oval

It's environmentally damaging
to replace natural grass with
artificial turf:
read on and find out why

Mimosa Oval: geological and physical setting and flora

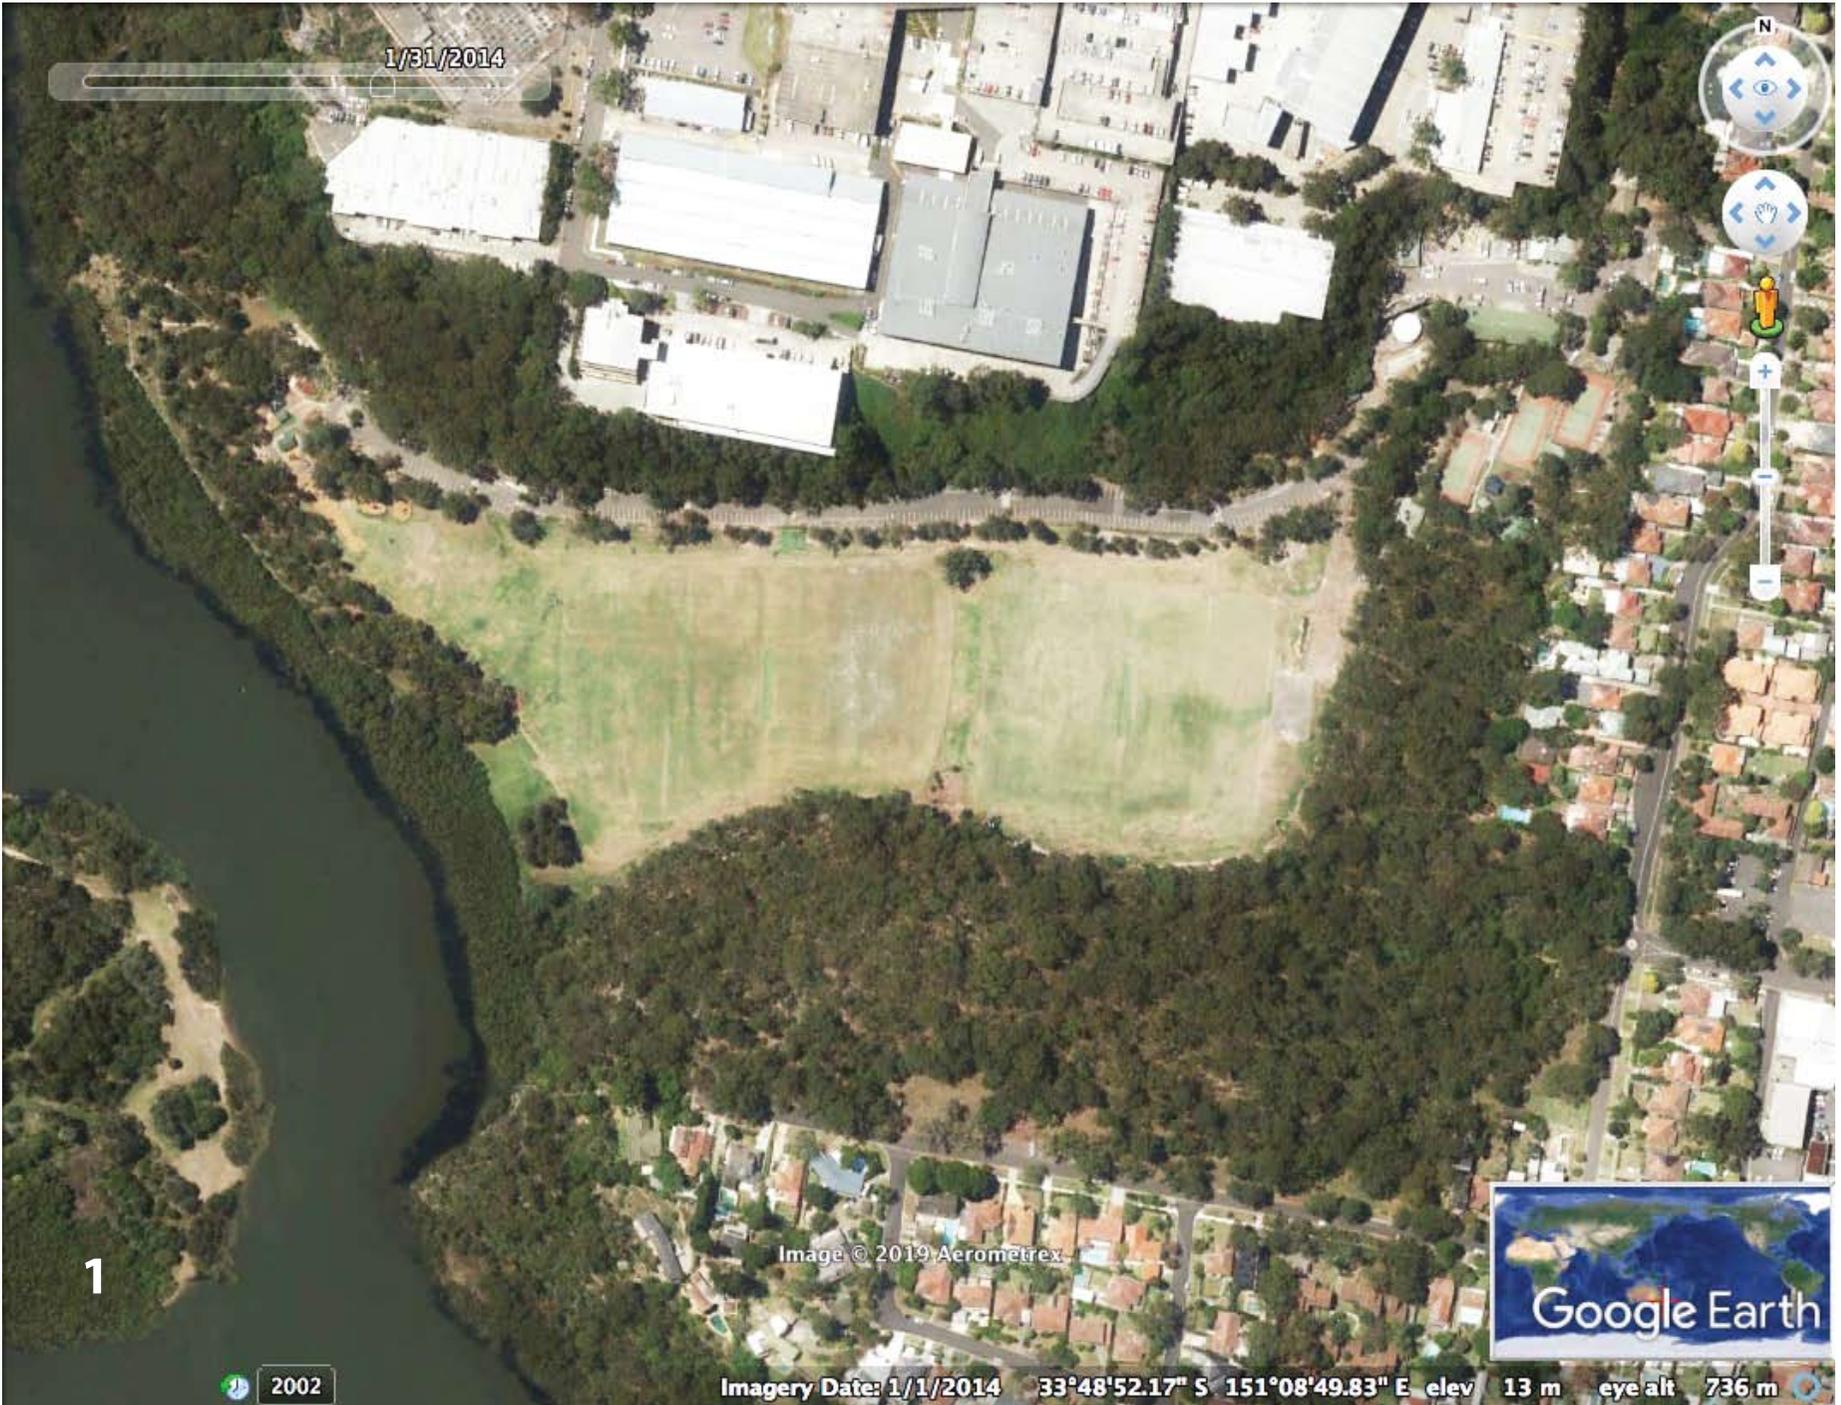
Image 1: 1/1/2014

This pictures the sportsground area in its original grassed form created from leveled waste in a site that had been quarried for sandstone. Healthy mangroves of both local species fringe the river in a border some 30 m wide.

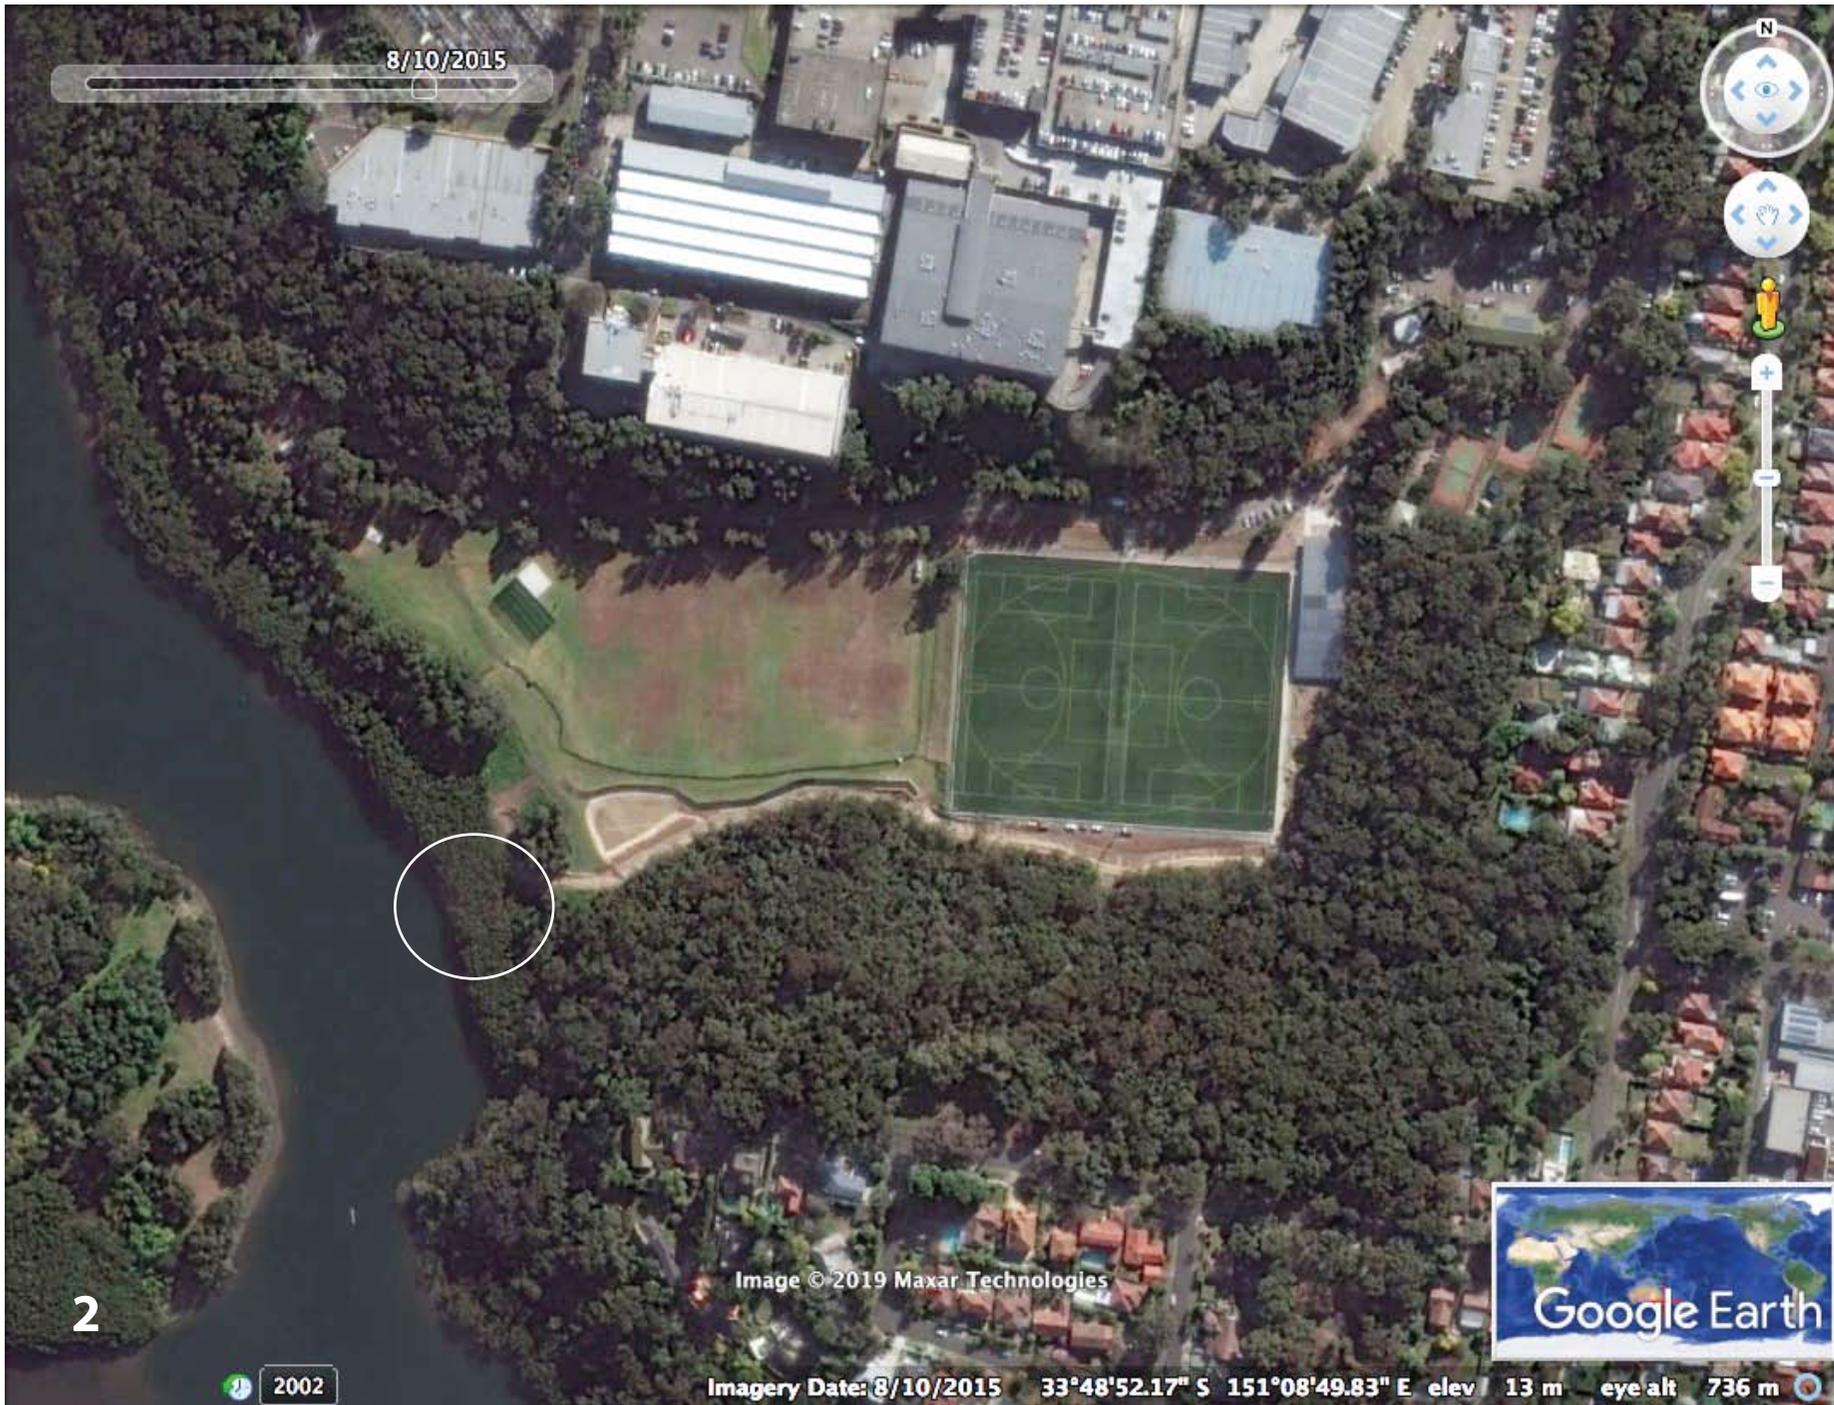
2

The conversion of the eastern oval is now complete, with drainage and detention pond fully functioning, designed to cope with runoff from the impervious surfaces, but there's already a sense that the mangroves below the exit of the drainage are changing colour for the worse.

Image 2: 8/10/2015

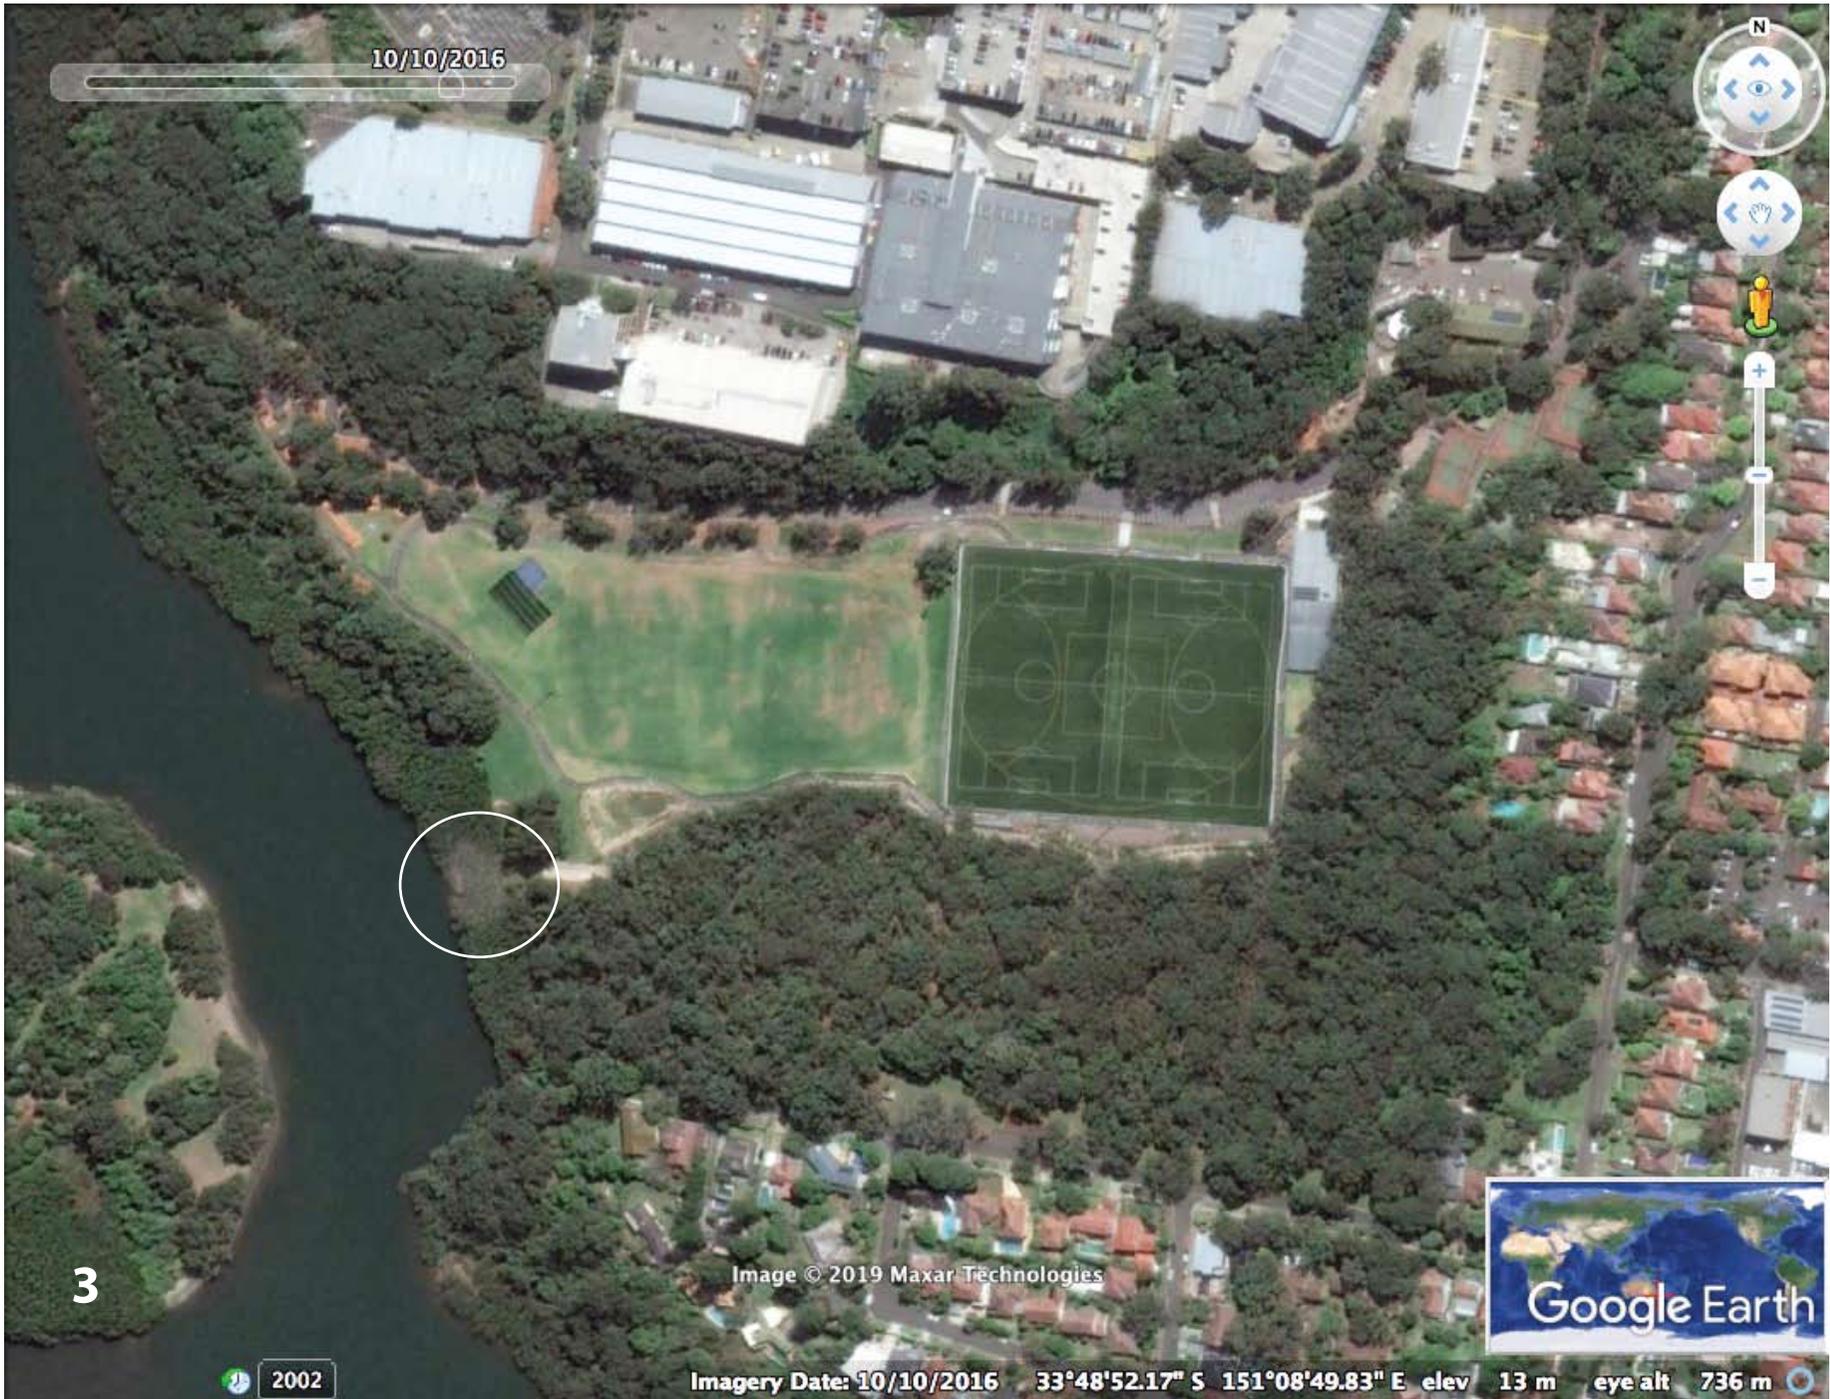
3

Only a year later, the mangroves are now largely dead along a 40 m stretch fringing the river at the point of drainage outflow.

Image 3: 10/10/2016

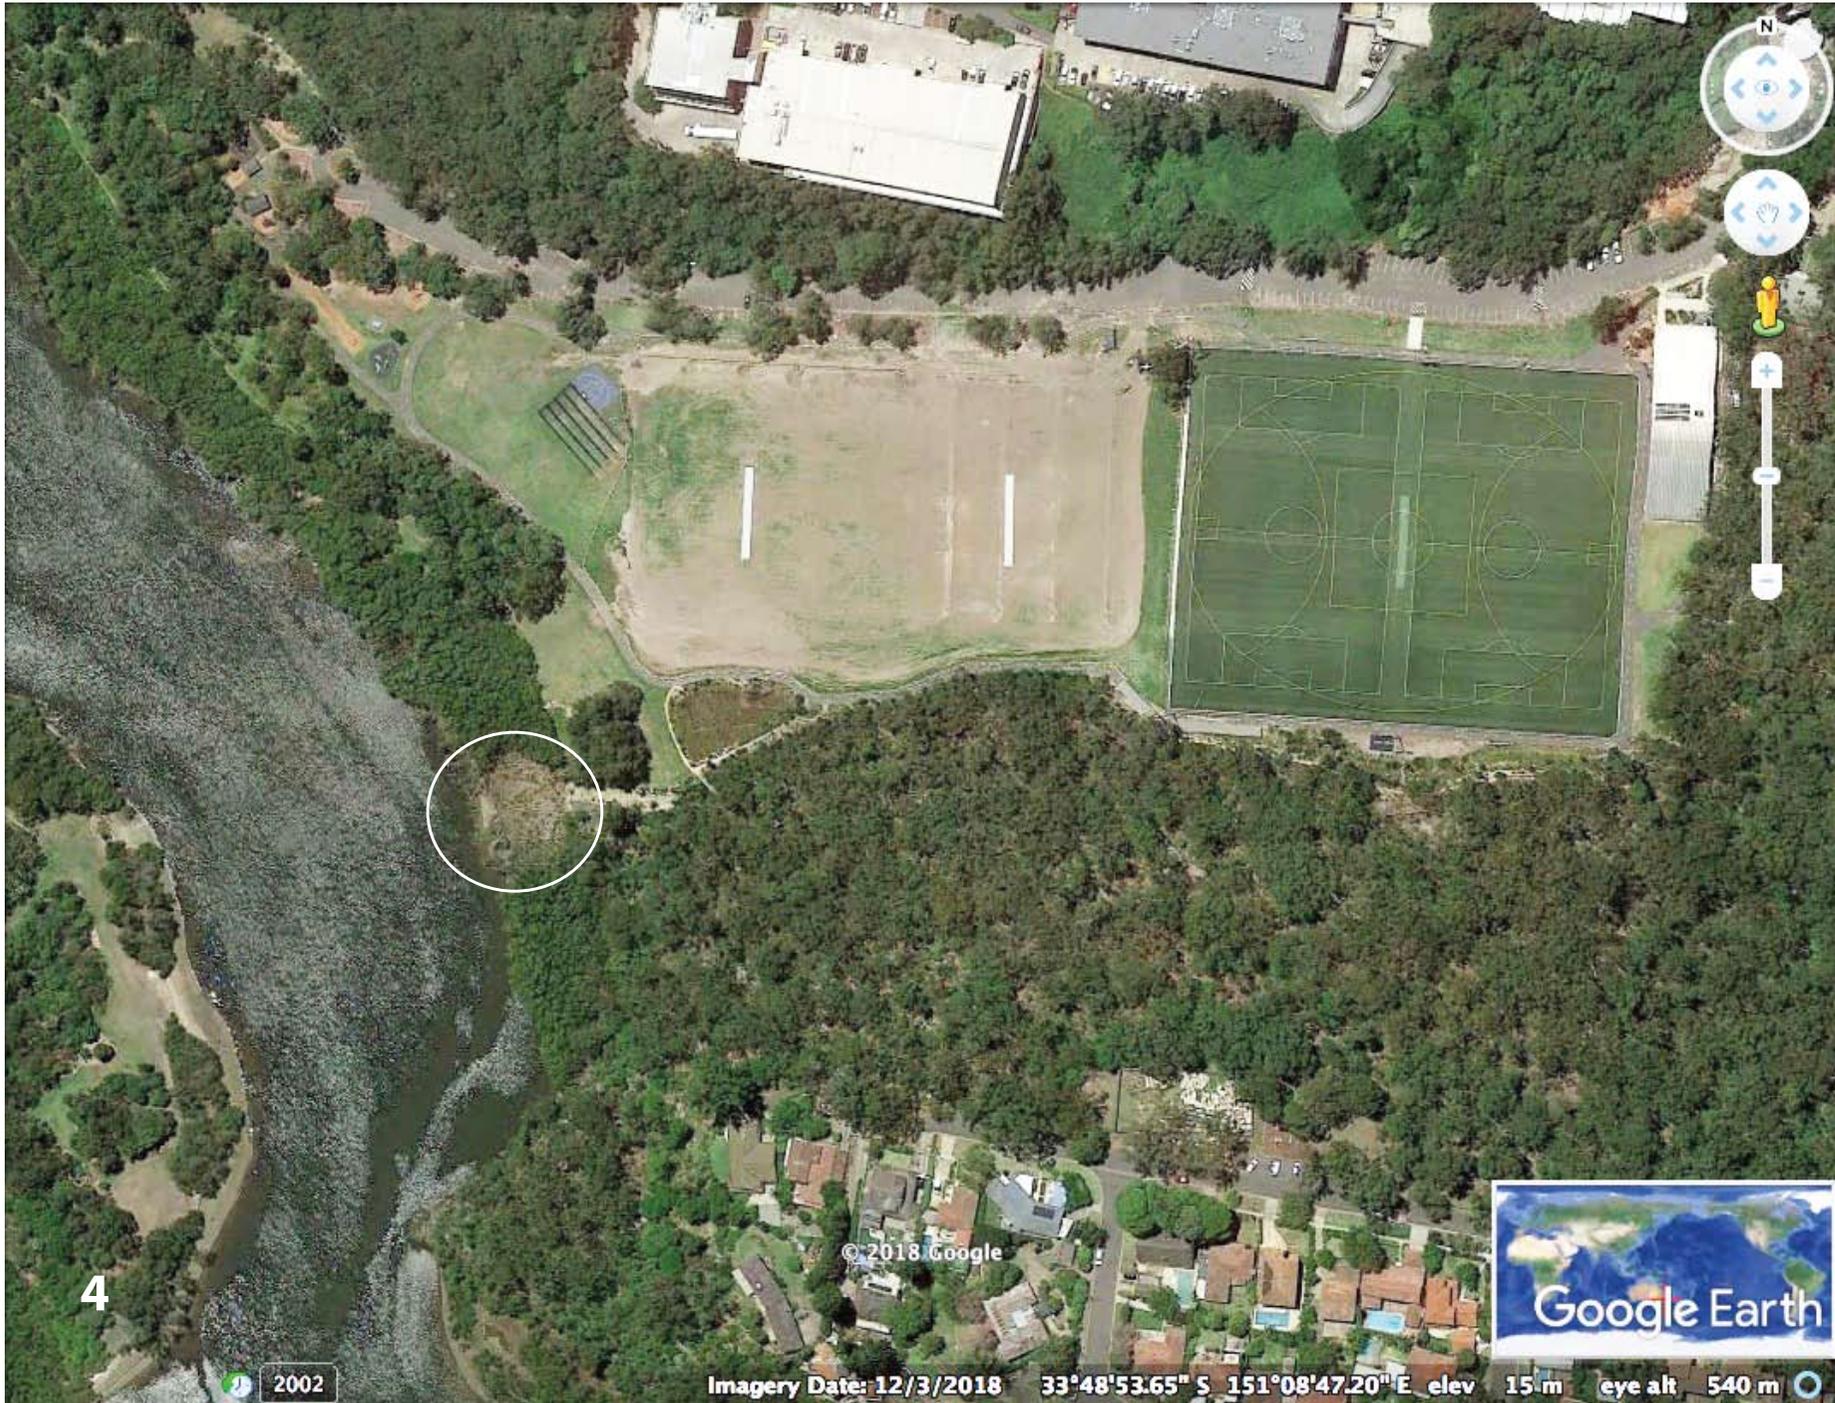
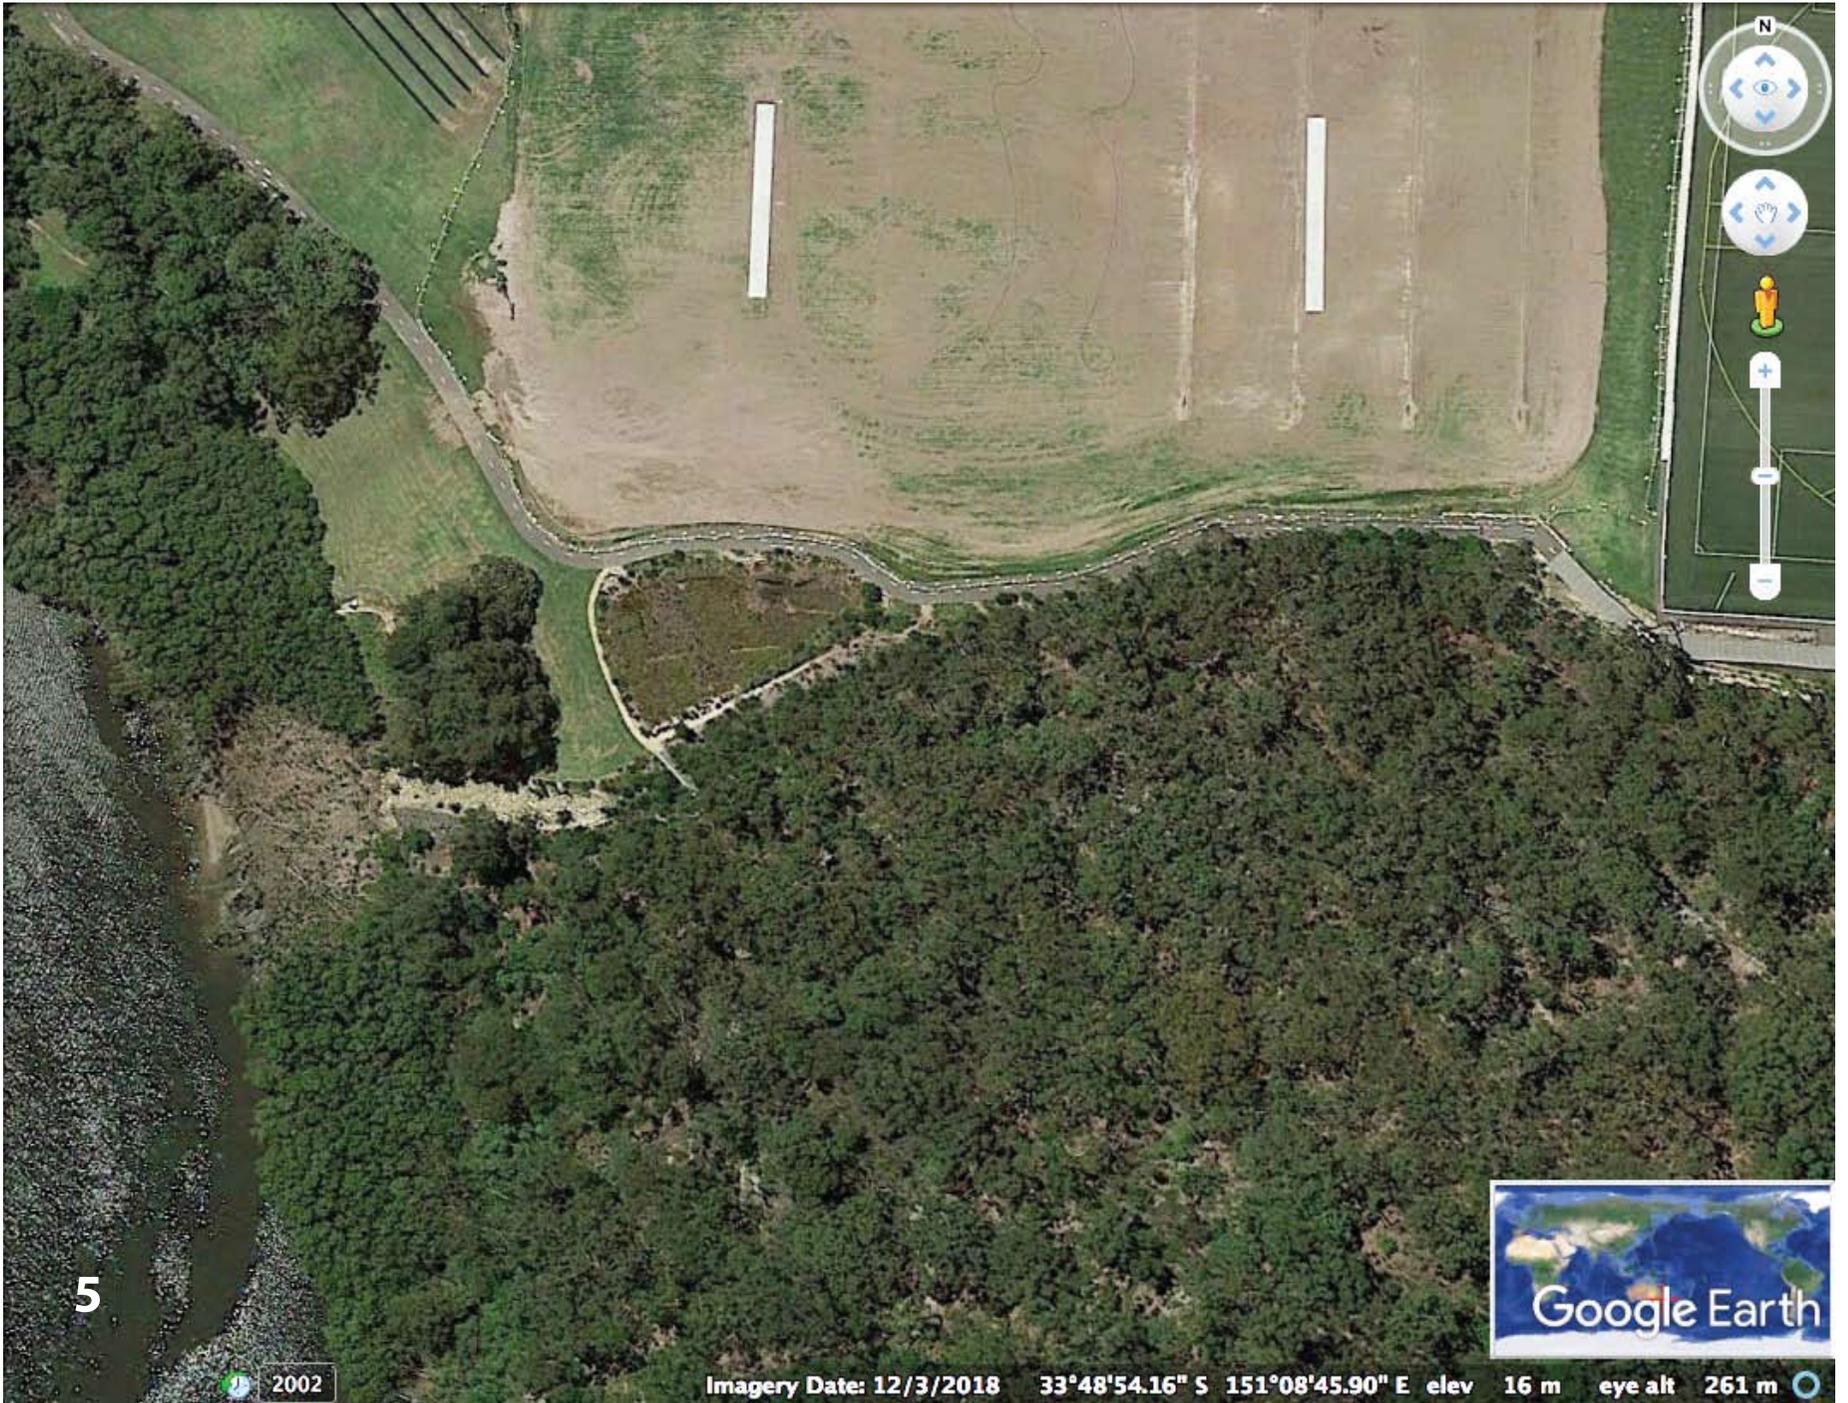
Images 4 and 5: 12/3/2018

Damage complete: there's no recovery and natural revegetation hasn't occurred.
